FAA Report AM-98/19
Analysis of Ditching and Water Survival Training Programs
of Major Airframe Manufacturers and Airlines

DOT/FAA/AM-98/19

Analysis of Ditching and Water Survival Training Programs of Major Airframe Manufacturers and Airlines

July 1998

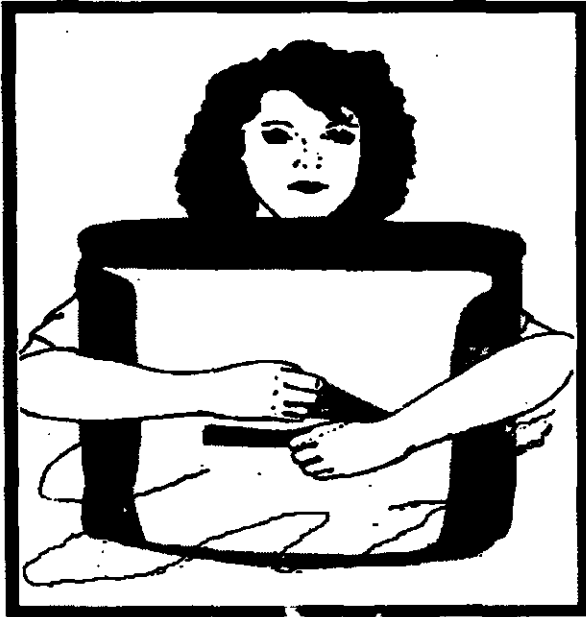
FIGURE 1
Vertical Flotation

advise passengers to hold the cushions in front of their bodies, to rest their chins on the cushions, to wrap their arms around the cushions with their hands grasping the outside loops, and to float vertically in the water (Figure 1). Others suggest that passengers lie forward on the cushions, grasp and hold the loops beneath them, and float horizontally (Figure 2).
